PROVEN SOLUTION LONG TERM PRESERVATION EXPORT SHIPMENT COVER FOR C-130 PROPELLER

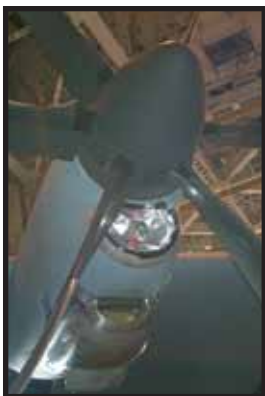
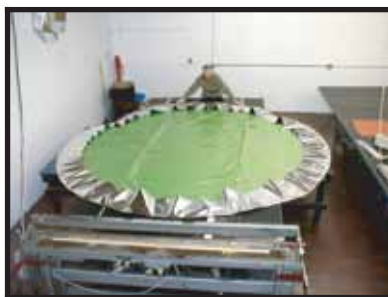
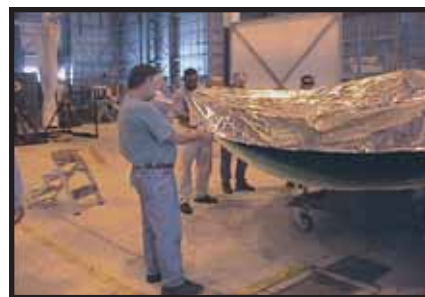
Heritage Packaging designed and fabricated a two piece circular cover from Cepac HD200 (a heavy duty barrier lamination from Controlled Environment Packaging, Inc. of Buford GA). The cover has 1/4" PE foam sealed at key locations on its interior surface to cushion against protruding points. The cover's design allows for "thru-bolting" the propeller to a mobile dolly while maintaining an airtight seal. 16 unit Desipacks are strategically placed inside the cover. The two pre-made parts of the cover are then heat sealed together around the outer perimeter. Then, utilizing a one way valve installed in the cover by Heritage Packaging, a vacuum is drawn, the cover is nitrogen flushed, and then a final vacuum is drawn. The goal was to maintain consistent interior humidity readings below 40%.

Humidity levels are monitored on a monthly basis using a digital read-out thermo hygrometer. The covers have consistently maintained humidity levels below 20%.
