PROVEN SOLUTION

C-130 HERCULES AIRCRAFT INTAKE & EXHAUST BARRIER COVERS

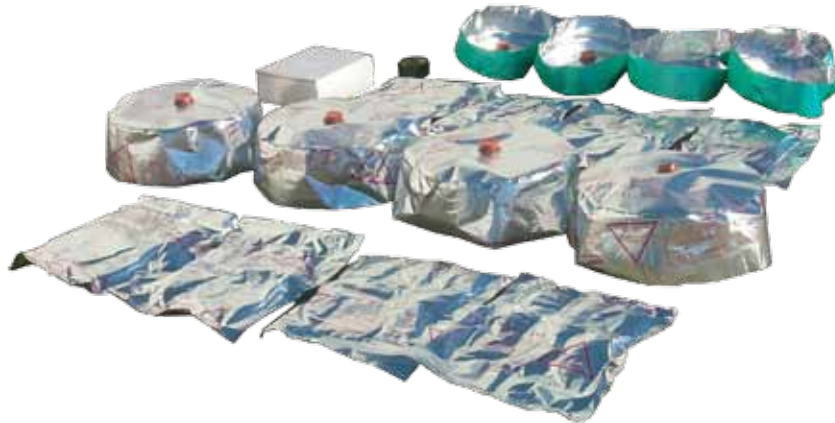
Heritage Packaging designed and fabricated contoured, "glove fit," covers from Cepac 113 & 143 barrier laminations. Each cover has a one way valve installed that allows the gas path to be conditioned by nitrogen purging and vacuum evacuation. Each aircraft is supplied with a "Ship Set" kit containing four intake covers, four exhaust covers, eight one way valves, 48 vacuum packed 16 unit desipaks, and non-corrosive tape used to form an airtight installation of the covers. Desiccants are inserted through both the intake and exhaust ports. Covers are installed, nitrogen is pumped in at one end while evacuation occurs at the other; conditioning the gas path. A < 40% humidity level must be maintained.
